# Comparison of *in vivo* wear of ceramic, metal and titanium nitride coated total hip arthroplasty heads

- This retrieval study compared *in vivo* wear of conventional CoCrMo, second generation ceramic (Bilox Forte), and TiN coated heads

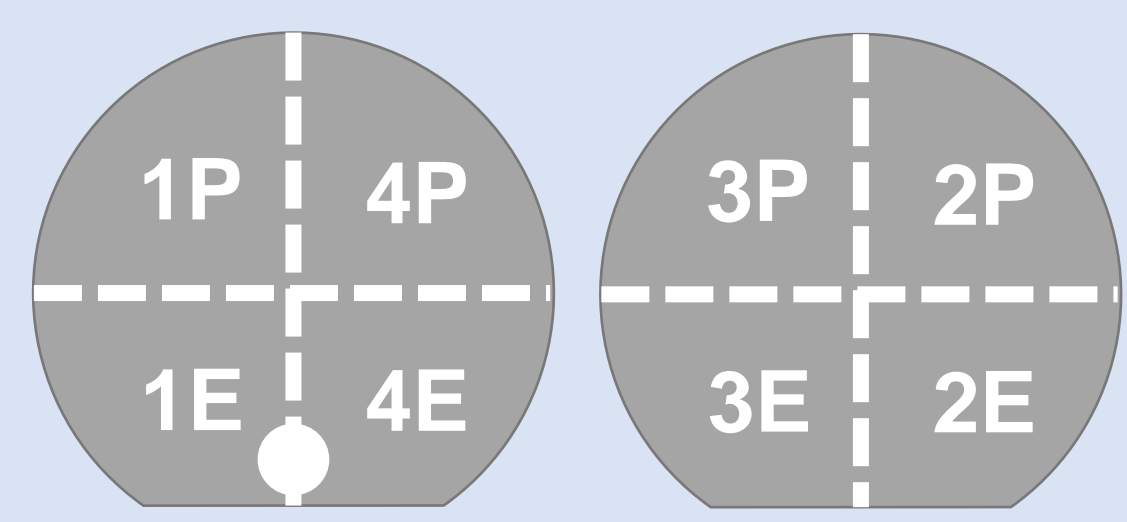
Heads were divided into eight equatorial (E) and polar (P) sectors relative to (dot – manufacturers logo)

- Light/Moderate/Heavy scratching/metal deposits
- Haziness
- Discolouration
- Embedded particles
- Pitting
- Wear scars

Each feature was scored as 0..3 depending on the area it covered (0-25%...75-100%)

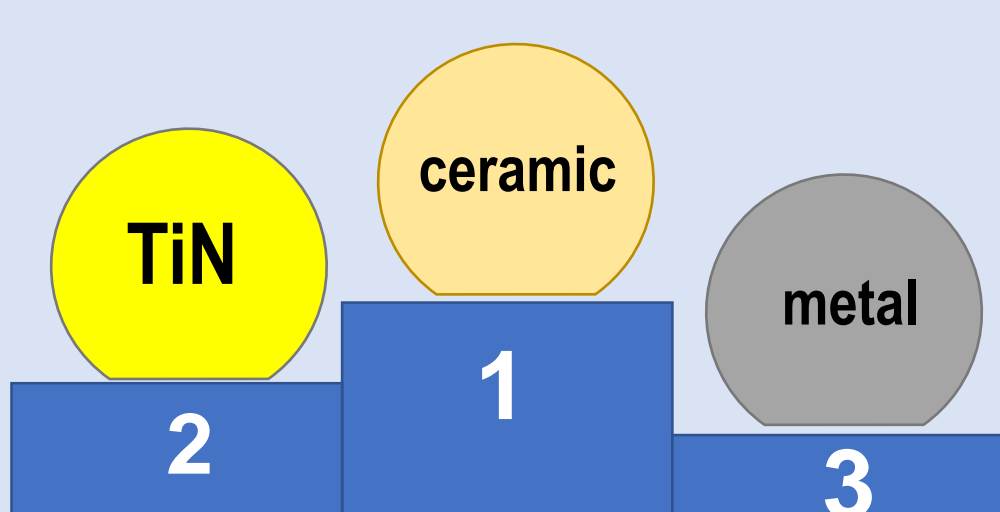
TIN	CER	MET
BWS Score	<b>34,2<sup>ns</sup></b> (range 12-57)	<b>10,7*</b> (range 5-21)	<b>40,7<sup>ns</sup></b> (range 15-86)
Mean surface roughness (W.B. areas)	<b>0,052*</b> (range 0,02-0,12) Non - W.B. parts 0,032	<b>0,028*</b> (range 0,02-0,05) Non - W.B. parts 0,028	<b>0,071*</b> (range 0,02-0,19) Non - W.B. parts
Unused reference sample	 Polished surface with multiple defects caused by the coating deposition process (in circles)	 Smooth surface with few areas with missing ceramic grains (arrows)	 Flat surface with few randomly oriented scratches (arrows)
Wear mechanisms of W.B. parts	 Abrasion by third bodies : scratching and removal of the TiN layer (2 cases)  Dislodgement of particles (arrow) from the coating – source of third bodies	 Localized pull-out of ceramic grains (in circle)  Transfer of Ti alloy debris <sup>5</sup> from metal components (arrow)	 Multidirectional scratches typically seen in W.B. areas (arrows)  Most scratches were caused by third bodies (in circles)

Other SEM findings	 Blister (arrows) formed by debonding of the coating due to corrosion  Massive coating debonding due to localized overload (impingement; 2 cases)	 Localized damage due to surgical tools (arrows); EDS spectra of metal deposits – presence of alloy containing iron (Fe) from surgical tools	 In patients with threaded, sandblasted Ti alloy cups alumina grains were common third bodies found on the heads, as confirmed by EDS analysis

- Ceramic heads had less *in vivo* surface damage in comparison to TiN and metal heads
- In Ceramic components damage was caused by transferred metal from implants<sup>5</sup> and surgical tools, while in metal and TiN coated abrasion caused by third bodies played an important role<sup>2,3,4</sup>
- Minimal wear rates of ceramic heads could potentially minimize PE wear and osteolysis<sup>1</sup>
